# Kings Lynn Bi-directional Area FEED Engineering Justification Study

Kings Lynn Compressor Station (7210)

## Technical Report

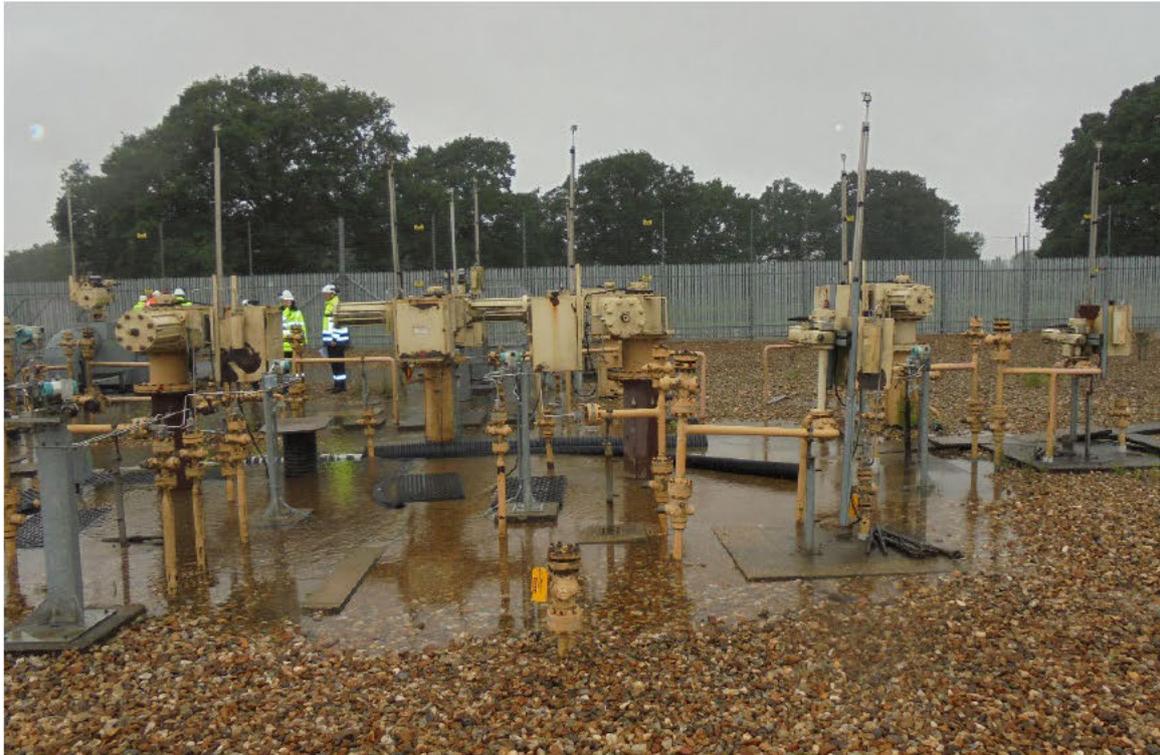
**Figure 10 – Bi-directional Area – June 2017**

During the site survey on the 28th June 2017, National Grid Operations confirmed that a number of valve actuators in the bi-directional area have been sized (oversized) to give fast valve closing times. The oversized actuators had caused a valve to break through its stops and complete a full 360-degree movement. Other valves have had the bolts between the valve and valve stem extensions stretched by the inappropriately sized actuators.<sup>2</sup>

There was also a significant amount of corrosion observed in the area particularly on the actuator cabinets.

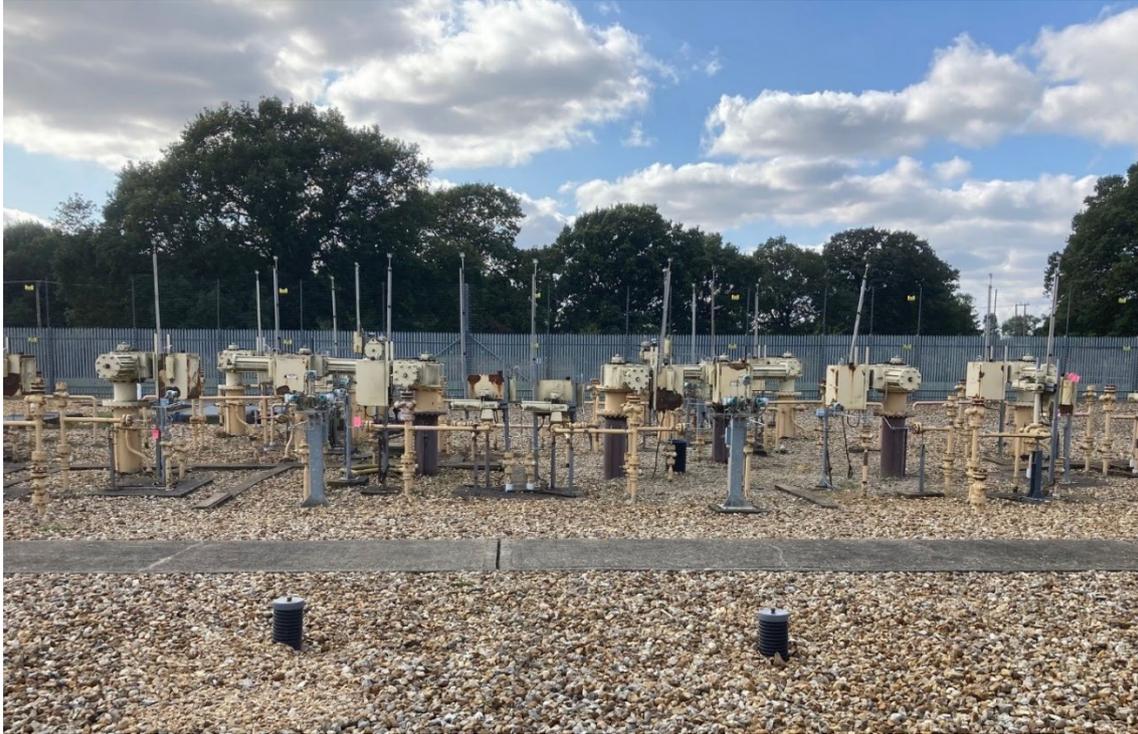
Figure 11 – Bi-directional Area – August 2021

In 2019 remediation work was undertaken on the small bore (50NB) pipework in the area. This included excavation of pipework and removal of concrete blocks attached to the pipework where possible to allow it to return to a level position. The area appears visually much improved in comparison with 2017 survey with the 50NB appearing straight and level in most places.

Also, in early 2019 some shallow land drain pipe was installed in the area, out-falling into an adjacent manhole to help reduce surface level flooding. Anecdotal evidence from site operational staff suggests, the area have been less susceptible to surface level flooding since this drainage was installed, however the pits have still remained flooded.

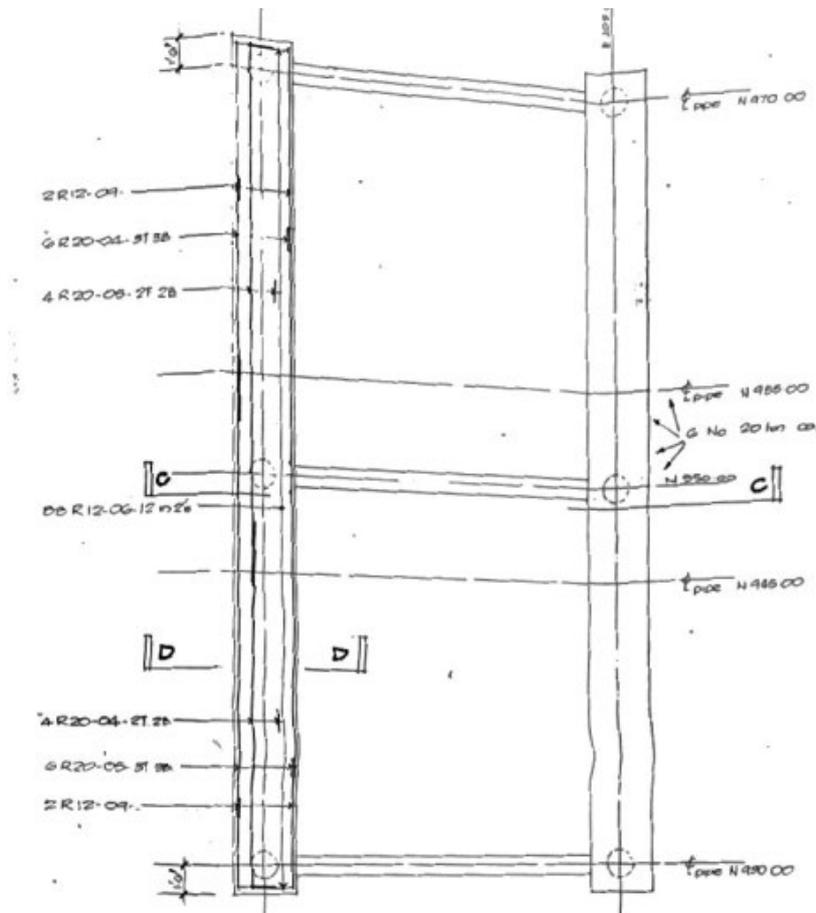
Figure 12 – Gas Council Valve Support Details (c.1971)

The primary learning from these was that the existing 1970s valves were supported on a piled raft foundation in the form of a piled beam across either side of the original six 900NB ball valves as shown in Figure 12 supported by six 20 tonne capacity piles.

The conclusion of this foundation review was that all ten of the existing 900NB ball valves in the bi-directional area are supported on piled foundation. As a result of this, the revised stress analysis undertaken (as described in section 5 of this report) has assumed that there has been no settlement of these valves. The previous 2018 stress analysis study assumed a displacement profile based on surface level observations.

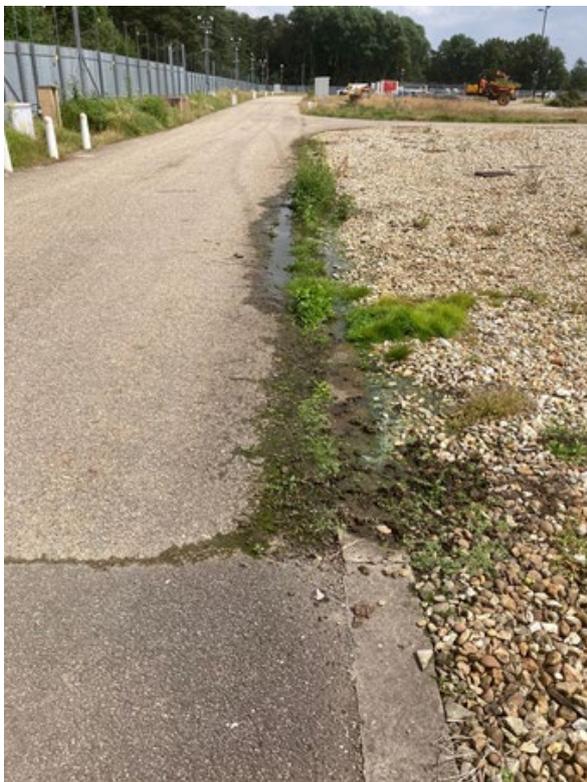
Figure 14 – Left: Evidence of Water Main Leak.

In July 2021 reeds were noted to growing alongside the site road adjacent to the area where the old control building was situated, see Figure 14 (right). After some excavations in the area, a water main leak was identified and rectified.

It is hypothesised that water from this leak has been flowing into the bi-directional area causing or worsening the localised flooding and adverse ground conditions.

It is recommended that the water levels in the bidirectional area are continued to be monitored to assess the effectiveness of the new drainage system in addition to the resolution of the water main leak.

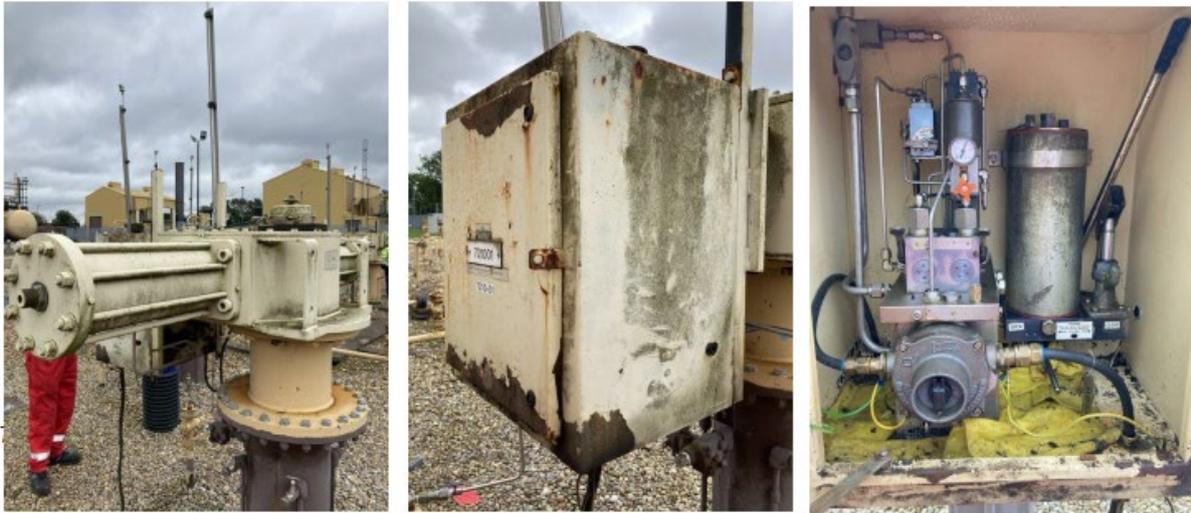
Figure 15 – Valve 01 Actuator Condition (from Power Mechanical Report SR-6485-01)

- General corrosion, including cabinet corrosion allowing water ingress into the cabinet.
- Leaking hydraulic reservoirs.
- Insecure vent stacks due for corrosion of fixings.
- Water build up inside actuator housing potentially causing corrosion damage to internals.
- Poor condition travel stops on pneumatic and hydraulic cylinders.

Figure 15 below shows the actuator, cabinet, and controls for Valve 721001.

- Replacement of existing cabinets with new stainless-steel enclosures.
- Replacement of soft seals, unserviceable hard components, control tubing, and vent stacks
- Further assessment of actuator internals to assess damage caused by water ingress.
- Recoating of actuator.
- Gas dehydrator filter replacements.
- Replacement of switchboxes.

It is recommended that the issues found are logged as plant status issues for the site.

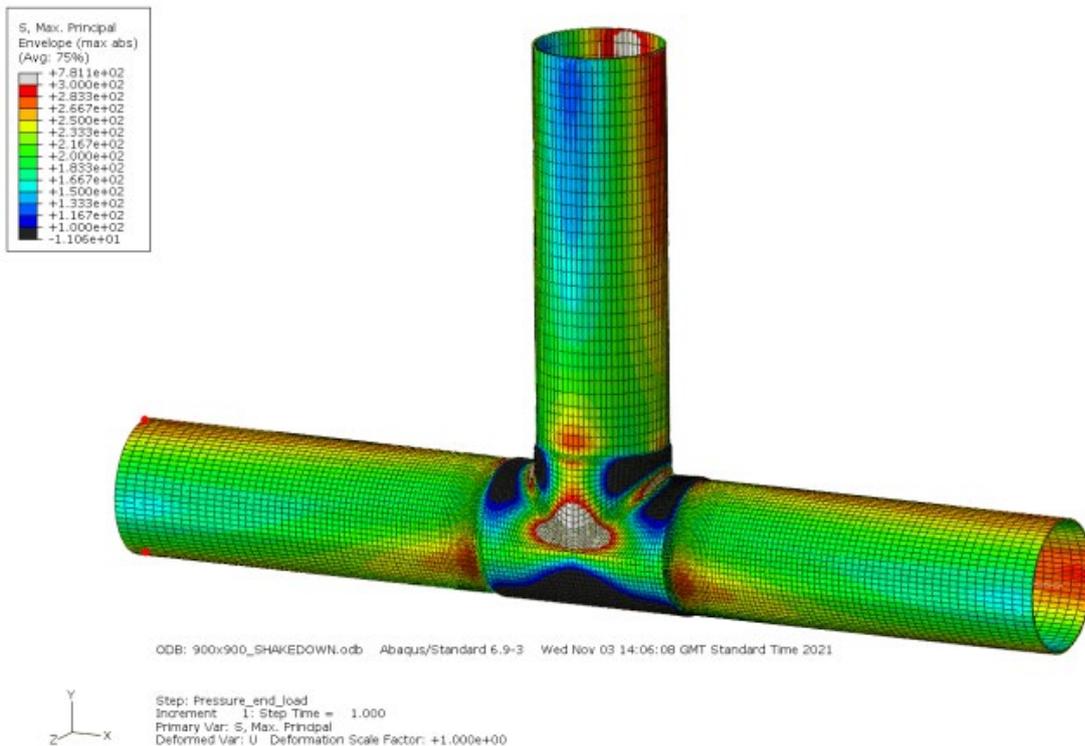
**Figure 18 – 900NB Equal Tee Abaqus FE Model**

In summary, the stress analysis with FEA concluded that the pipework has a fatigue life up to the required year, 2050, and resolved all but one of the identified potential IGE/TD/12 stress exceptions.

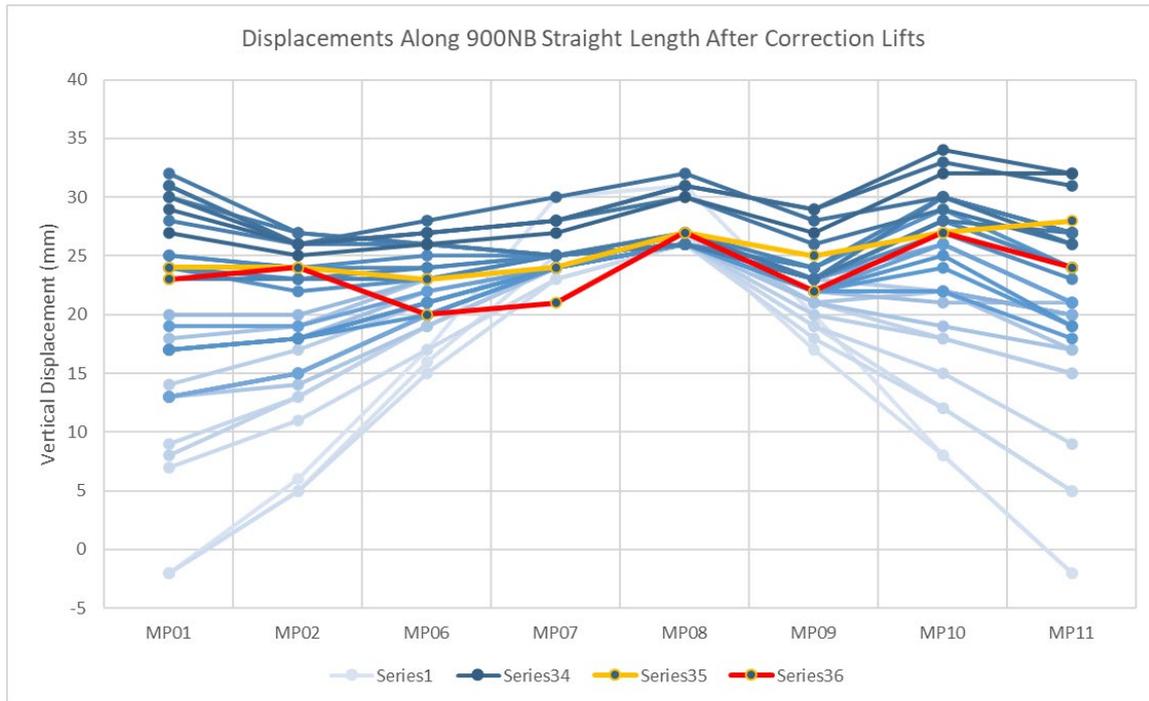
**Figure 30 – Trial Area Monitoring Points Displacement Over Time**

In Figure 30, the lightest blue line shows the deformed profile of the pipe to be relevelled and each darker shade line represents the profile at various intervals as the geopolymer is being injected (pipe is being levelled). The yellow line represents the survey completed two months after the final injection took place and the red line is 8 months.
