RIIO-T2 Re-opener

St Fergus Terminal Plant 1 Aftercooler

**Engineering Justification Paper
Version 5
January 2023**

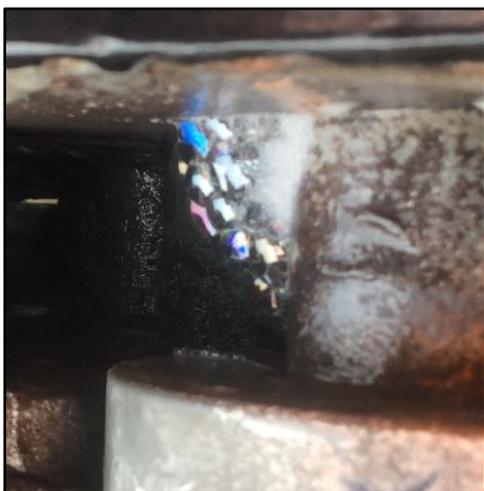
Figure 14 Leak Detection testing

- 5.26 At a pressure of 30 Bar leaks were detected on the uppermost fin fan cooling tubes at the header box inlet located on Bank C. At a pressure of 40 bar leaks were detected on the header box to Bank A. At this point the commissioning was stopped, the Aftercoolers depressurised and made safe. Figure 14 below shows the leak detection fluid identification of a defect on Bank C.

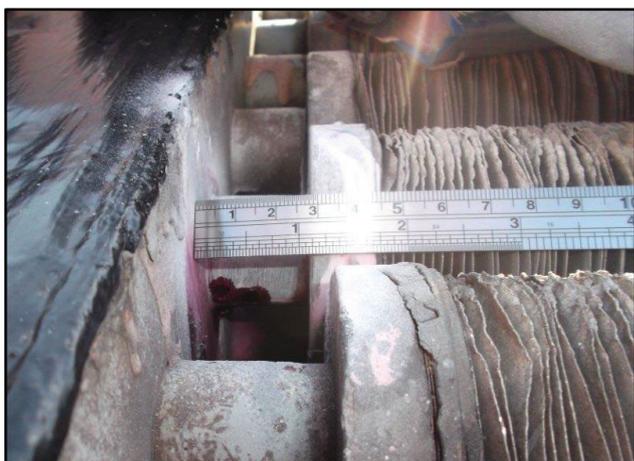
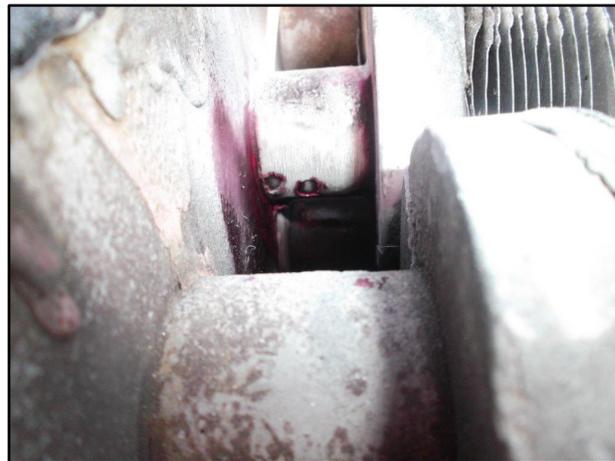
5.27 The corrosion defects detected were initially thought to be that of a “Crack” like defect, a failure type that is not identified through the IRIS. External close visual inspection was undertaken followed by inspection using a “Dye Penetrant”, this proved to be the only practical method for the identification of the corrosion defect(s) due to the limited space and access restrictions at the header box location. The report from the Dye Penetration testing is included in Appendix 5.

5.28 The testing undertaken showed that instead of cracks these were in fact through wall corrosion defects. These being shown in the photos below (Figure 15 and Figure 15).

Figure 15 Tube Bundle Header Connection Through Wall Defects

Figure 16 Tube Bundle Header Connection Through Wall Defects

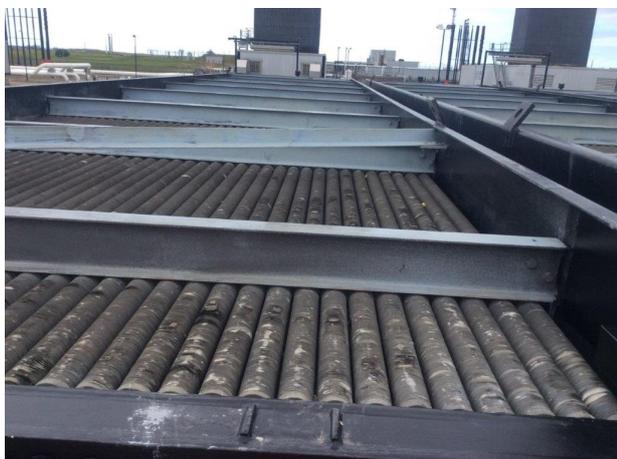
5.32 [REDACTED], the Original Equipment Manufacturer (OEM) for the fin tube bundles, confirmed that the original design life for these assets was 25 years. The Plant 1 aftercooler has been operational since the terminals commissioning, and therefore we are operating the system well in excess of this design life as these assets are now operating at nearly twice the design life at 49 years old, within harsh environmental climatic conditions.

Figure 17 Plant 1 Fin Tube Bundles

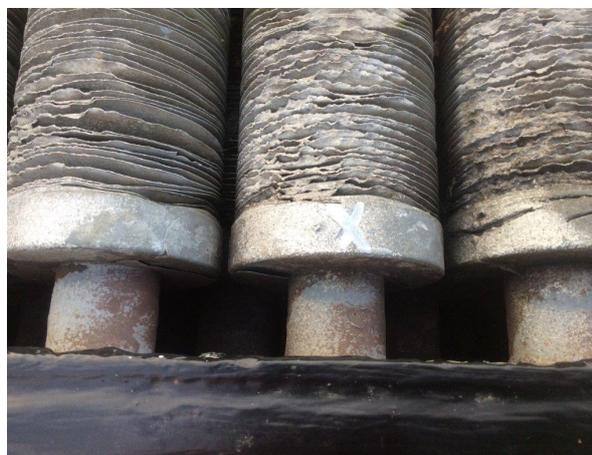
Figure 18 Fin Tube Bundle Header Connection

5.33 The corrosion defects identified on the top layer of the tube bundles at the tube ends where they connect onto the header have resulted in loss of containment. Access to the middle layers of tubes is restricted, as there is little or no effective available room to access them, as shown in the figures above, without the removal of the upper and lower layers of tubes. Therefore we are restricted to internal inspection, rather than external inspections, in order to determine condition assessments.

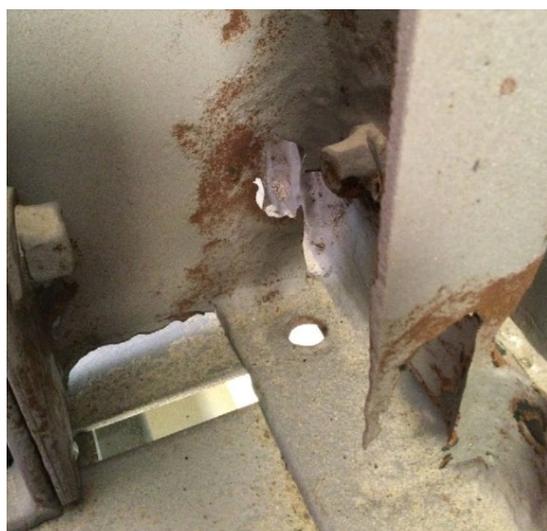
Figure 20 Aftercooler Frame Corrosion

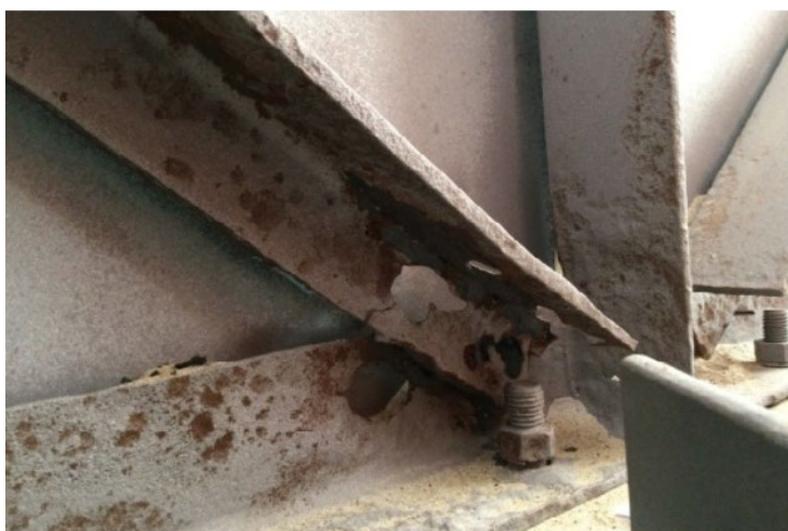
Figure 21 Aftercooler Frame Truss Corrosion

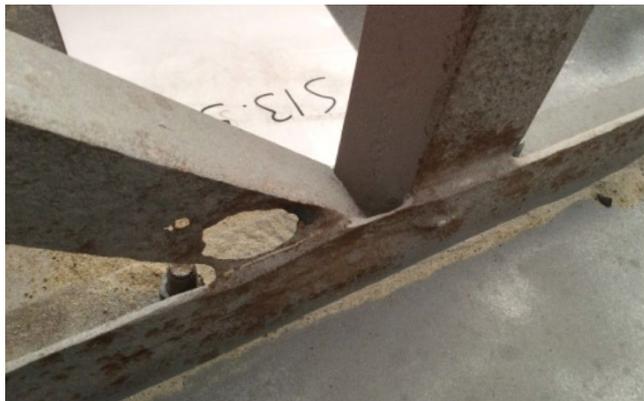
5.43 In addition to the main lattice girders, there are 39 secondary lattice girders. The Condition survey undertaken identified that 33 had visibly suffered from corrosion; 26 of the 33 girders that had noticeably suffered from corrosion, were deemed by [REDACTED] to have suffered severe corrosion and the other seven had suffered moderate corrosion.

Figure 22 Secondary Lattice Girder Corrosion

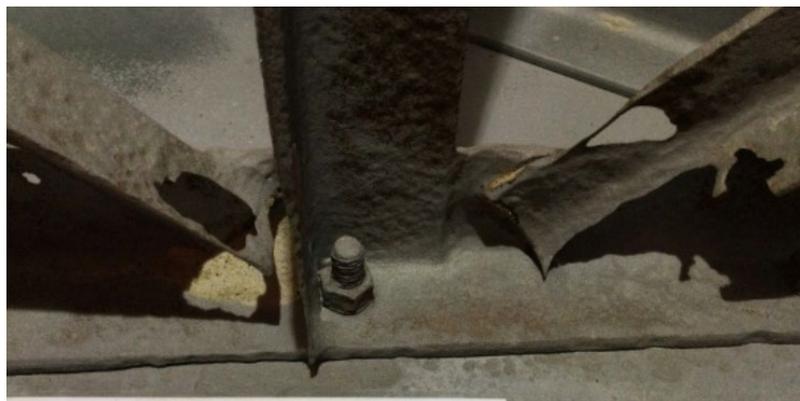
Figure 23 Secondary Lattice Girder Corrosion

5.46 This second survey has established that severe corrosion is evident on the bottom sections of the main and secondary lattice girders in many areas. Feedback from the second survey highlighted that *“In response to the anticipated question ‘Can the structure be salvaged?’ the author’s response is that it can be strengthened so that it is stronger than it was immediately prior to the old Aftercooler Units when it was successfully supporting them; however, this approach wouldn’t be recommended due to the following:*

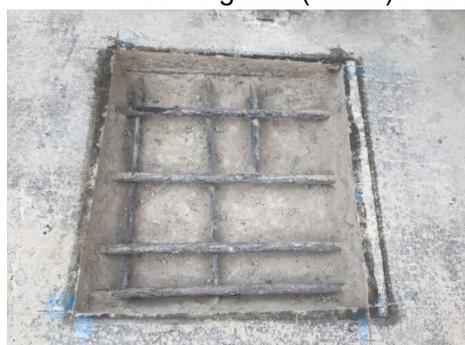
Figure 25 Foundation Inspection Trial Hole

- An independent residual life assessment was undertaken on this existing Plant 1 Aftercooler piled foundation in September 2021. This included visual inspection of concrete and reinforcing bars (Rebar) within three inspection trial holes.

- Laboratory Tests of the Chloride content of concrete dust samples showed these were well below the 0.4% trigger in The Department of Transport document CS462 Repair and Management of deteriorated concrete highway structure.

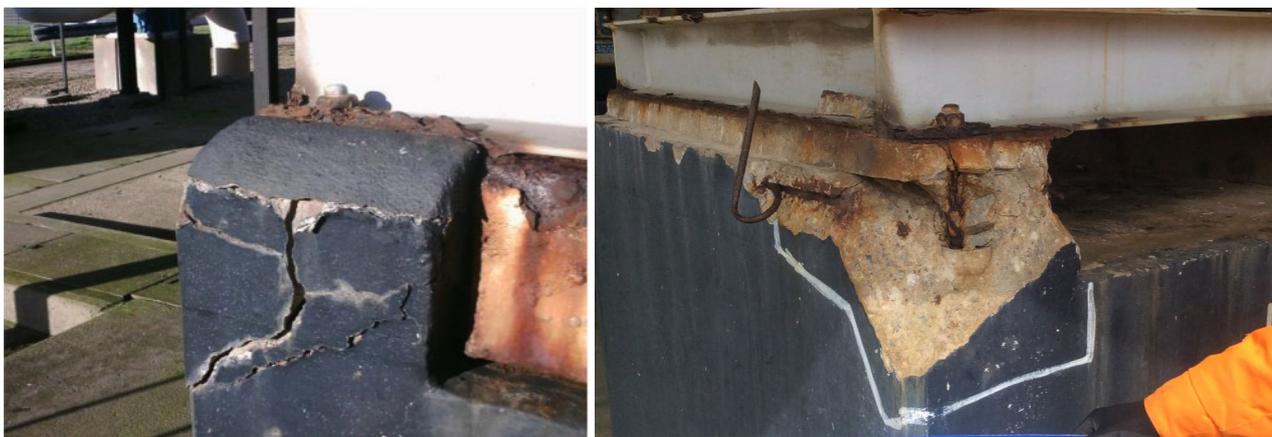
Figure 27 Plant 2 Aftercooler Concrete Fan Plinth cracking Figure 28 Plant 2 Aftercooler Concrete Fan Plinth 36 Severe Concrete Issues

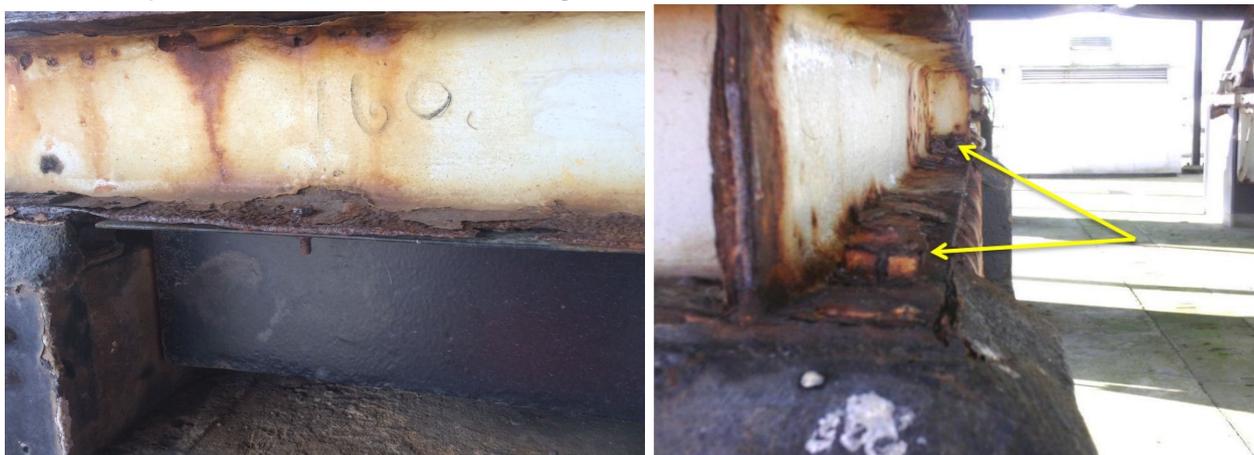
5.60 Corrosion is present across all the fan shafts and the main anchor points are severely corroded. All fans have four main anchor bolts, with most of these fans having one or two of the bolts being completely corroded, as shown in the figures below.

Figure 29 Photos Highlighting Corroded Fan Main Anchor Bolts

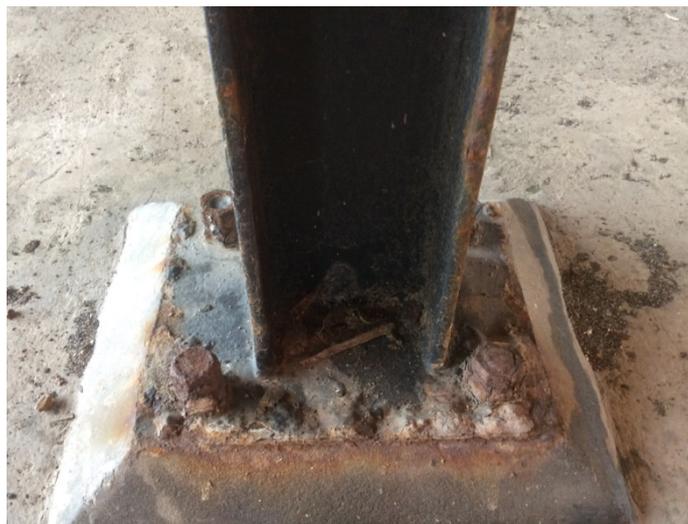
5.61 In relation to the frame, widespread corrosion is seen across the internal and external columns. The photos below show a range of columns from across Plant 2 aftercooler, including general surface corrosion on the columns and around the anchor baseplates.

Figure 30 Plant 2 Column 9 Moderate corrosion to column and baseplate

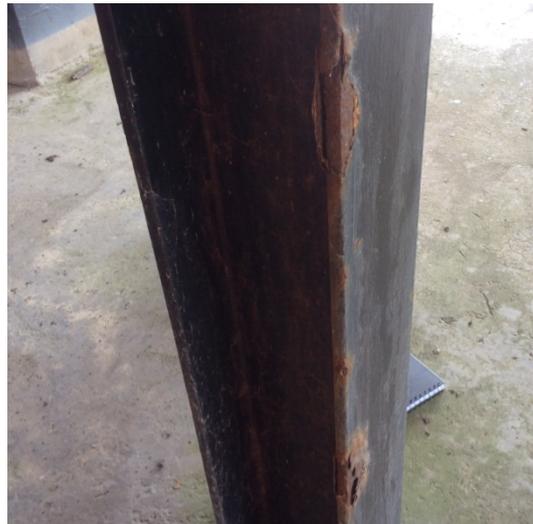
Figure 31 Plant 2 Column 20 Moderate corrosion of column
