RIIO-T2 Re-opener

St Fergus Terminal Plant 1 Aftercooler

**Engineering Justification Paper
Version 5
January 2023**

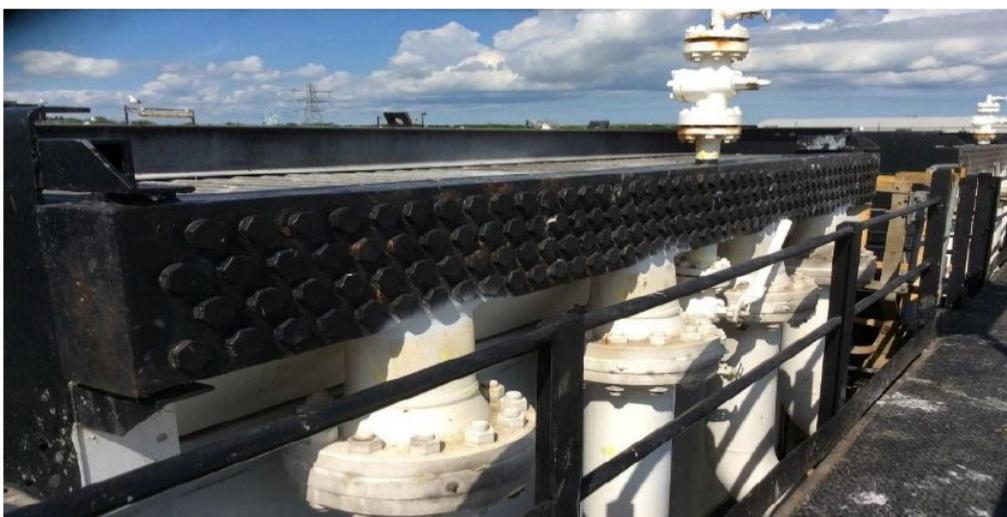
Figure 11 Tube Plugs on Header Box

- 5.16 Both IRIS and NFT approaches were utilised, with access to the cooling tubes undertaken via the plugs on the header box as shown in Figure **11** below.

- 5.20 One limitation of this testing is that no readings are provided for the first 25mm from the tube end, which includes where the tube interfaces within the box header wall. Additionally, external defects are not detectable unless they exceed at least 60% wall loss which is a very rare failure mode in fin-fan tubes apart from where corrosion occurs close to the header box where the tubes are not protected by the aluminium fins.

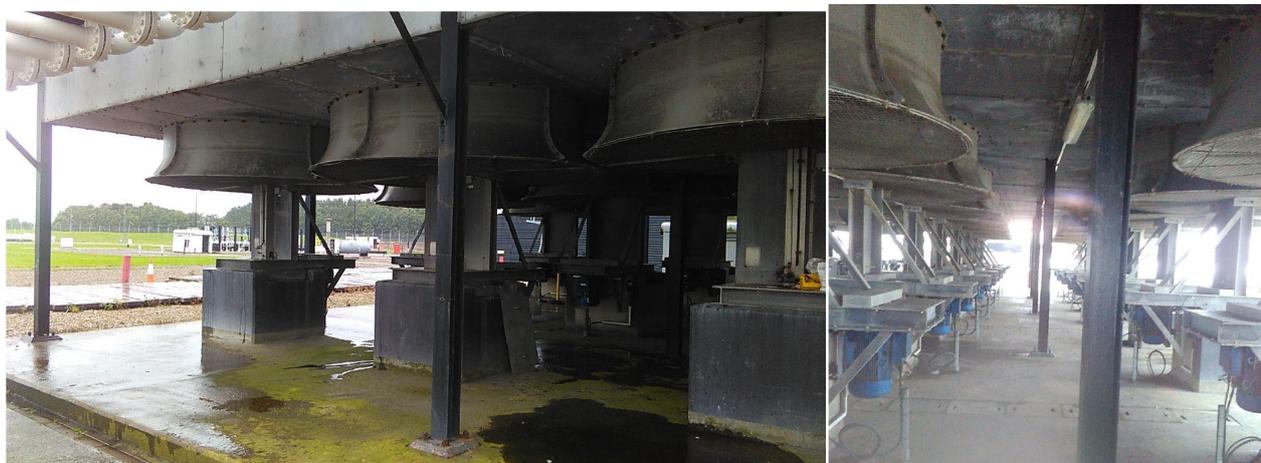
Figure 24 Sections of Concrete Foundation and Fan Plinths at Plant 1 Aftercooler

5.48 Records held show the Plant 1 Aftercooler foundation was laid in 1973 constructed using “Class A” concrete with a 28-day cube strength of 21 N/mm² to the concrete design code of CP110, effective from 1972. The photos below show sections of the concrete foundation and concrete fan plinths at Plant 1 aftercooler.

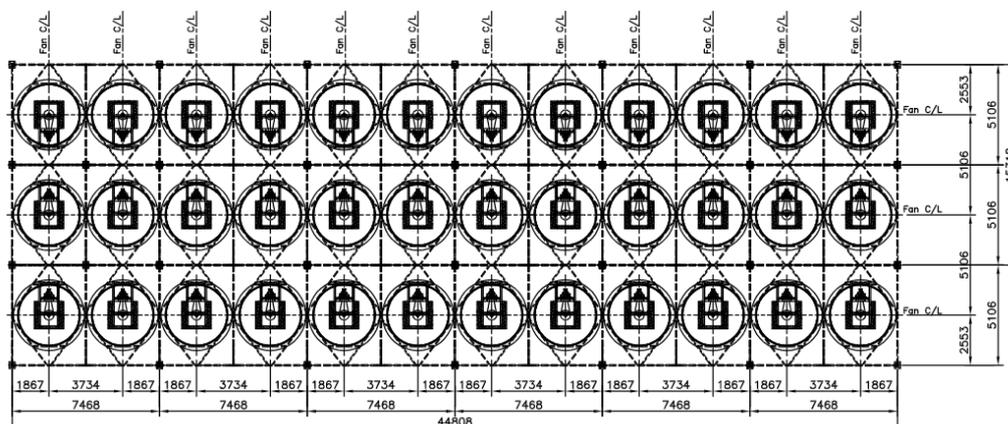
Figure 26 Plant 1 Aftercooler Plan View

5.51 Plant 1 Aftercooler has 36 pulley driven fans to provide cooling to the cooling tubes within the structure. The plan view below shows the location of these fans within the structure. Fan blades are balanced as pairs and installed in matched opposite position

5.52 A visual survey of all 36 fans was undertaken covering Motors, Pulleys, Fan Shafts, and bearings was completed in September 2018 (Appendix 7). Through this survey all 36 motor pulleys and fan pulleys were identified to be end of life, with four shafts having found to be snapped. Additionally, for the shaft bearing assemblies all but one of have been assessed as end of life, along with 12 of the 36 motors. Several defects were raised for the drive mechanisms, shown in fan assembly category on the table overleaf.

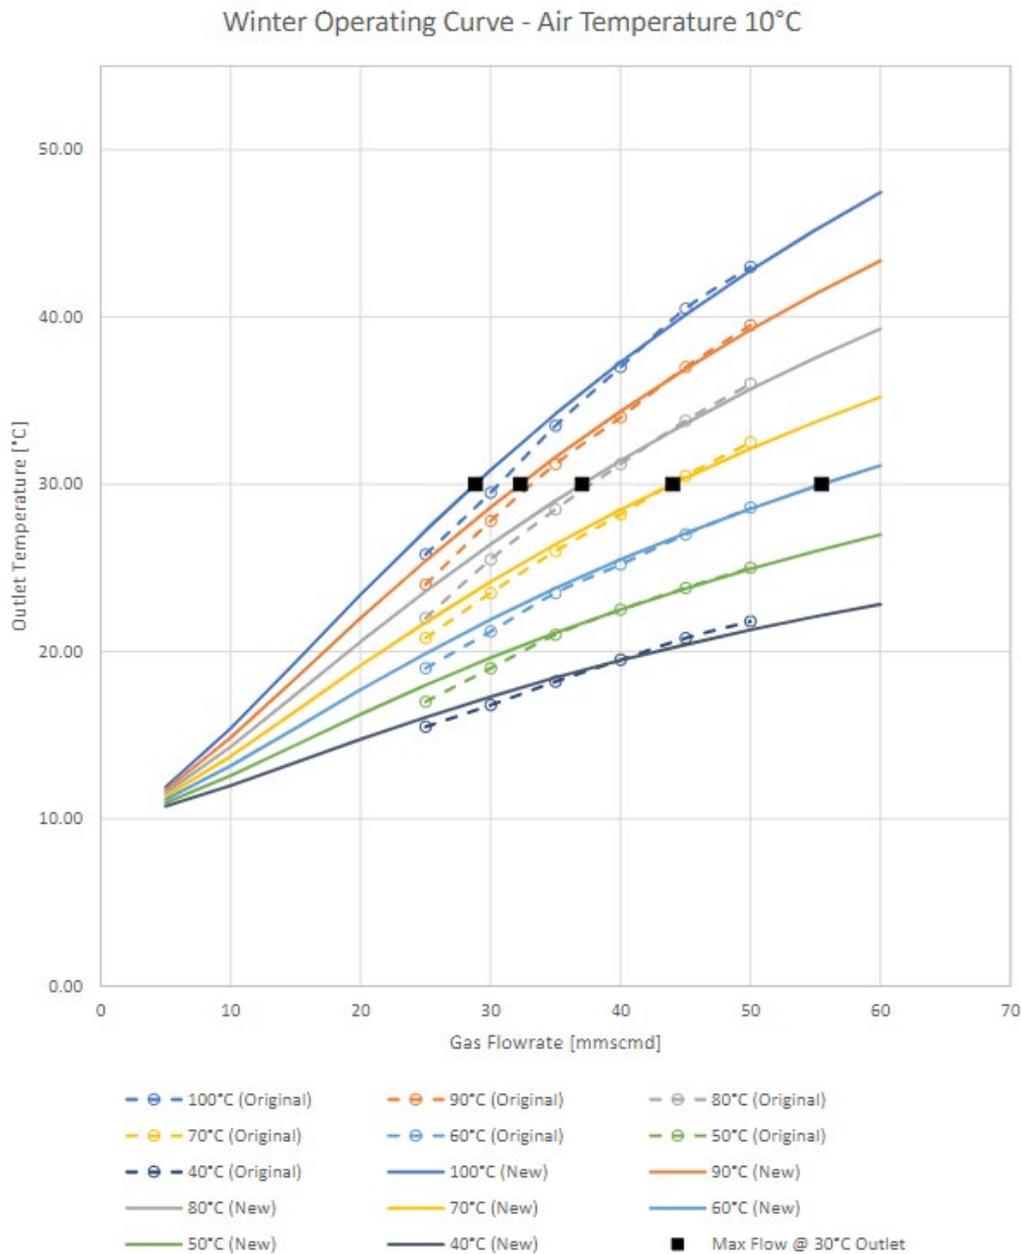
Figure 36 Plant 1 Aftercooler Design Winter Operating Curve - Air Temperature 10°C

- 9.15 Our revised modelling results has been plotted into operating curves for two scenarios (Summer conditions with an air temperature of 20°C, and Winter conditions with an air temperature of 10°C). Existing curves developed for the original Plant 1 Aftercooler were sourced and plotted with the curves developed through the Aspen modelling completed for this replacement design.

- 9.17 Using the curves and input data on air temperature, inlet gas temperature and flow through the aftercooler the outlet temperature from the aftercooler can be estimated to ensure that the asset operation meets the downstream integrity parameters, in line with the Aspen EDR tool modelling. Figure 35, below, and Figure 36, overleaf shows the Operating Curves for Summer conditions with an Air Temperature of 20°C, and Winter conditions with an Air Temperature of 10°C
