RIIO-T2 Re-opener

St Fergus Valve Actuators

**Engineering Justification Paper
January 2023**

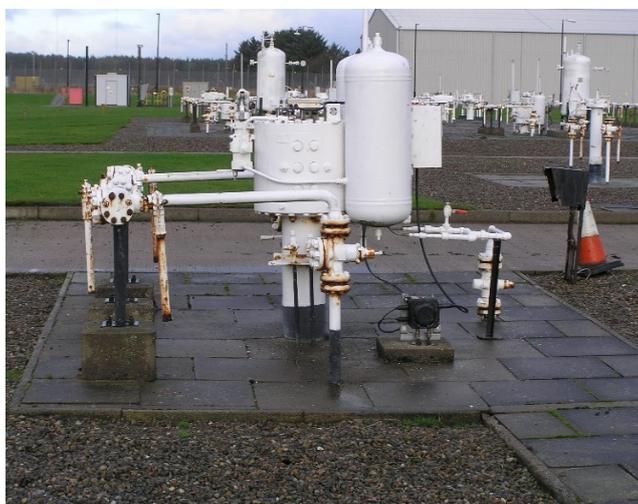
Figure 3: Typical gas-powered Actuator at St Fergus terminal

3.2 A site wide valve actuation system powered by a single gas actuating pipework operates numerous safety valves, emergency shut down systems, vent systems, automated start-up and shut down processes and isolation valves. In total the gas actuating pipework system currently provides the power for the operation of 143 gas-hydraulic Shafer Actuators across the terminal, critical to its safe operation.

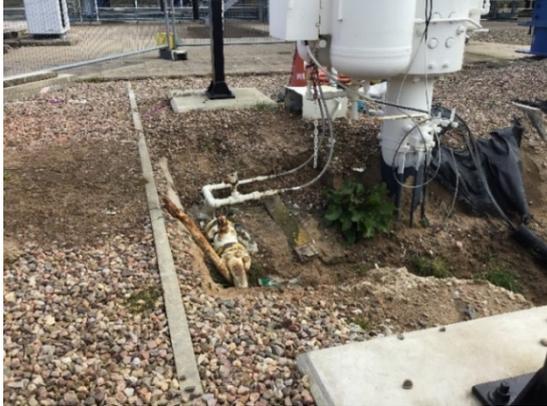
Figure 44: Corrosion and ground movement threats to Actuators

4.14 To demonstrate the scale and complexity of pipework defects a range of typical examples is shown below:

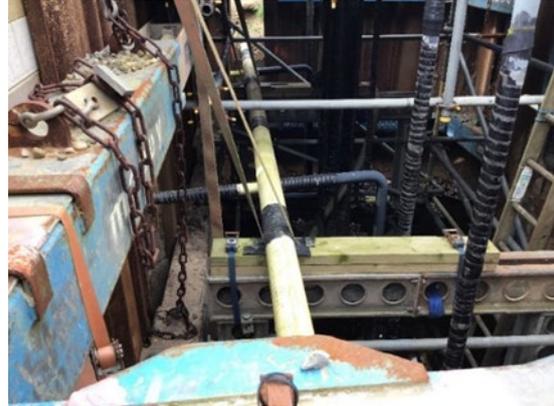
Figure 5: Temporary structure mitigating risk from clashing Actuator gas pipework movement

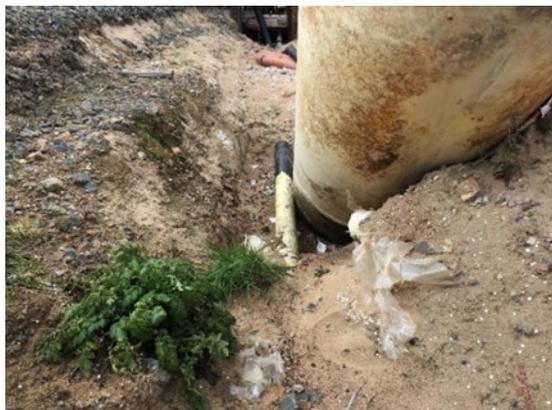
Figure 6: Actuating pipe clashing with main gas line due to ground movement

presents significant safety and operational risks to both site personnel and site operations due to many critical external corrosion defects and threats from ground movement which has collided Actuator pipework and equipment into main gas pipelines. A failure or isolation of the gas actuating pipework eliminates valve actuation operation of up to 143 valves and can render the terminal inoperable.

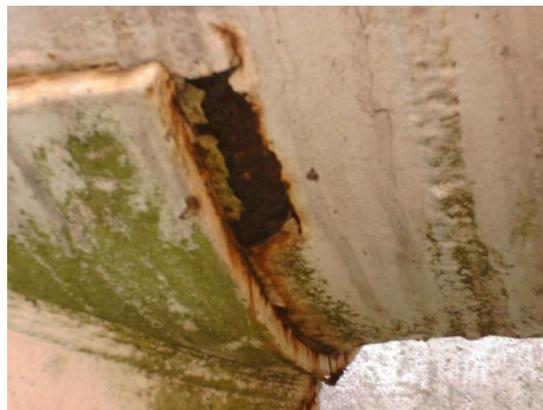
Figure 7: Corrosion under pipe support - a difficult failure to identify

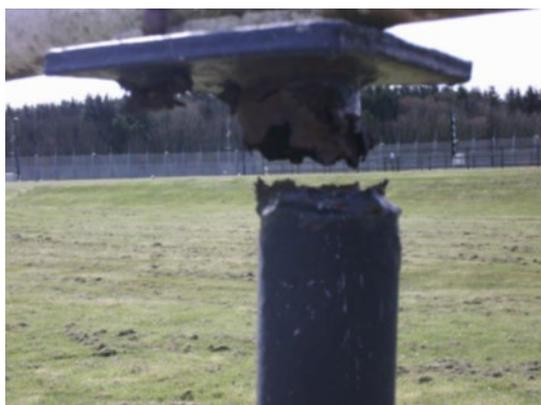
Figure 8: Damaged pipe support through corrosion and movement

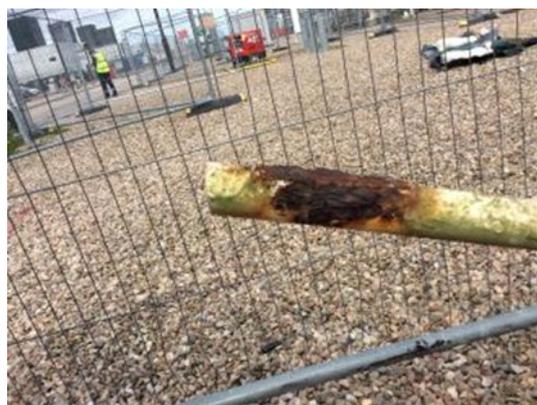
Figure 9: Through wall corrosion requiring replacement to continue operation

- 5.1 The severity and prevalence of Actuating pipework corrosion defects, coupled with four separate findings of through wall corrosion/leaks and the range of temporary repairs and mitigations currently in place, shows that asset failure is occurring and will continue until intervention takes place.

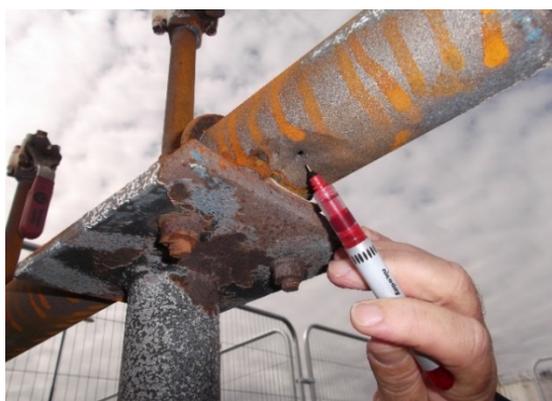
Figure 10: Through wall corrosion leading to pinhole leak requiring replacement

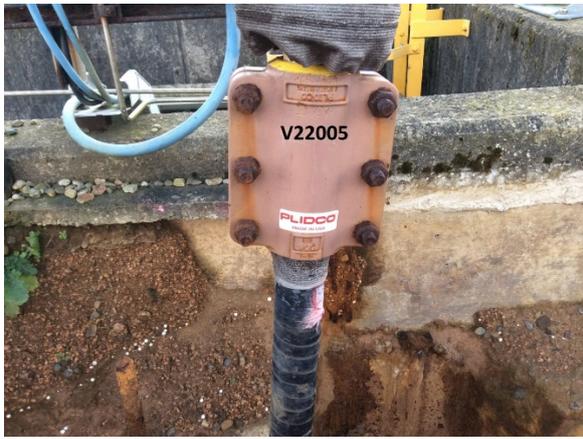
Figure 11: Temporary Plidco Clamp on Actuating pipework riser

4.15 Due to the original design of the Actuating pipework, gaining isolation to repair defects on many sections of the system is not possible without shutting down significant portions of the entire terminal. As such, nine separate Plidco Clamp repairs (see register in Appendix 6) have been implemented to manage significant corrosion defect risks and avoid significant plant outages to repair on the Actuating pipework. These repairs are deemed temporary and as such will need to be cut out and replaced if the Actuating pipework is to remain in use.

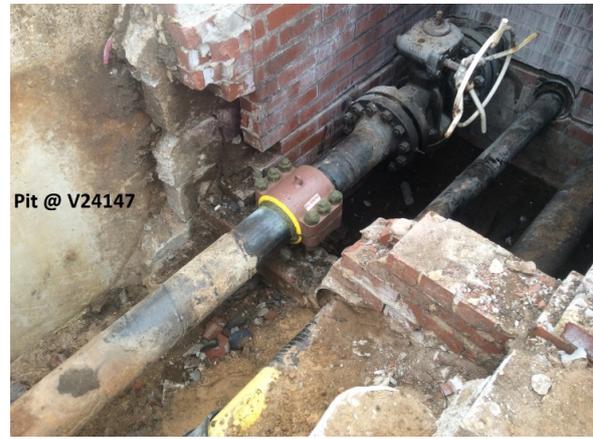
Figure 12: Temporary Plidco Clamp on Actuating pipework at pit wall transition

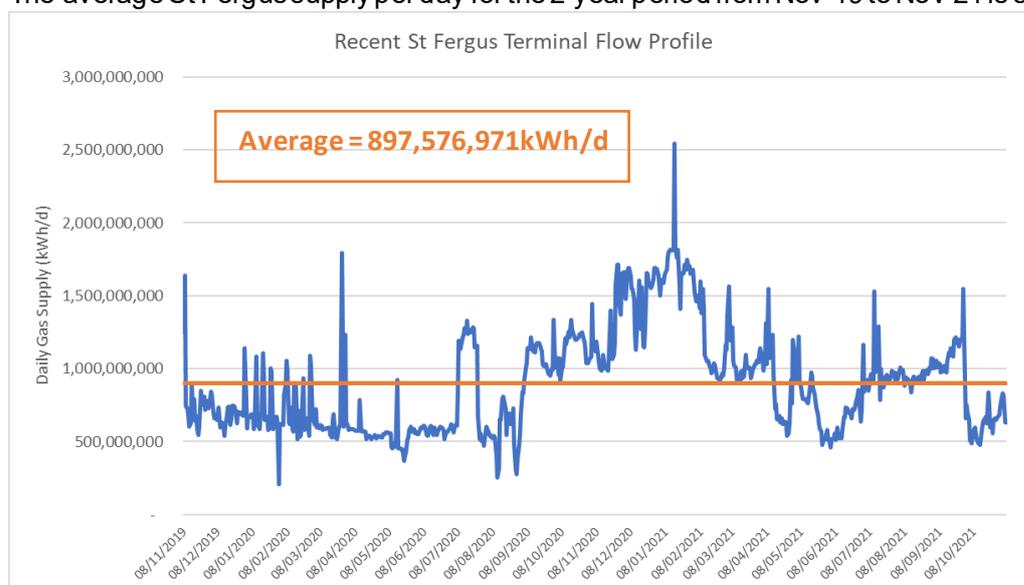
6.3 The average St Fergus supply per day for the 2-year period from Nov-19 to Nov-21 is shown below.

Figure 13: St Fergus Terminal flow profile

6.4 The average daily supply from St Fergus terminal over the last 2 years is 897,576,971kWh/d, utilising the constraint cost assumption of [REDACTED] equates to an average daily constraint cost of [REDACTED].
