RIO-T2 Asset Health Re-opener St Fergus Unit Decommissioning

**Engineering Justification Paper
January 2023**

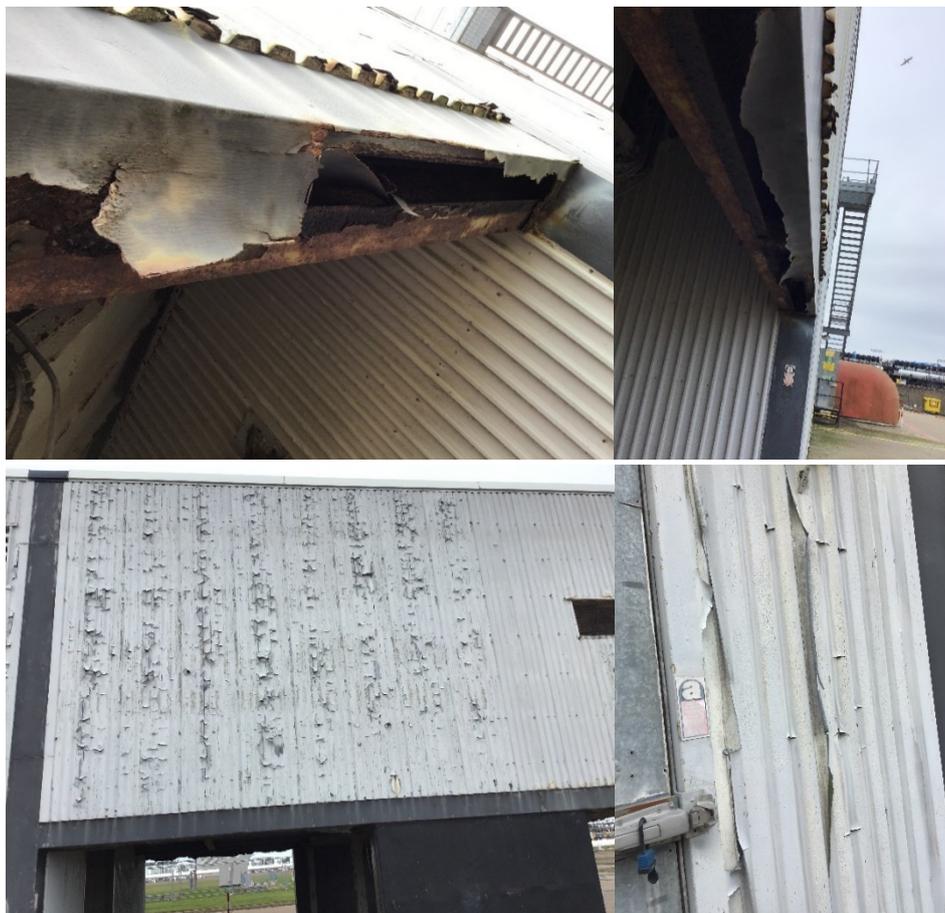
Figure 4: Coating breakdown of Galbestos cladding

- 4.1 The site asbestos management plan (Appendix 3) highlights that clusters of residue found throughout and around the inner and outer cabs of all the gas turbine units are asbestos containing. This is because the metal cladding is lined with an asbestos containing bitumen. The Galbestos mentioned in the report is specifically on Unit 1A, however all the cabs are the same design excluding Unit 2A which had cladding replaced in 2013. The Galbestos bitumen was outlawed in the late 1970s and has been replaced on other sites across the network. A briefing on this material is provided in Appendix 4.

4.4 In addition to this, it should be noted that evidence showing severe structural deterioration of the exhaust stacks was found on site. A conditional survey conducted by [REDACTED] is included in Appendix 2. For example, protective coating on the outside has started to degrade and peel off while the combustion exhaust exit section is severely corroded. The exhaust stacks present a safety risk due to the lack of information on Unit 2C and the known poor condition on Unit 2D. The earlier we can remove these exhaust stacks, the lower the overall cost will be to complete this task.
